Experimental Investigation on the Impact Behaviour of Composite Laminate

Abstract

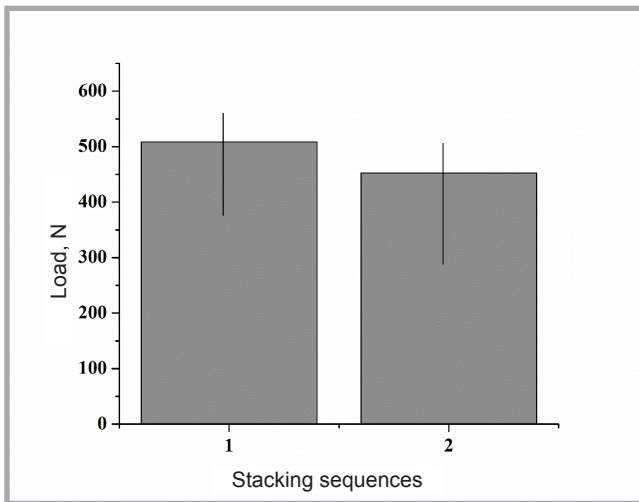
Figure 6. Mean load values in N of the stacking sequences tested.

sequences, including mean, standard deviation, median, minimum, and maximum are shown in Table 4 and Figure 6. The results of ANOVA indicated significant differences among the various stack-

ing sequences ($P < 0.001$). Post hoc test pointed out that $[0/90/-45/45]_{2s}$ showed significantly higher load values than $[45/45/90/0]_{2s}$ ($P < 0.05$).

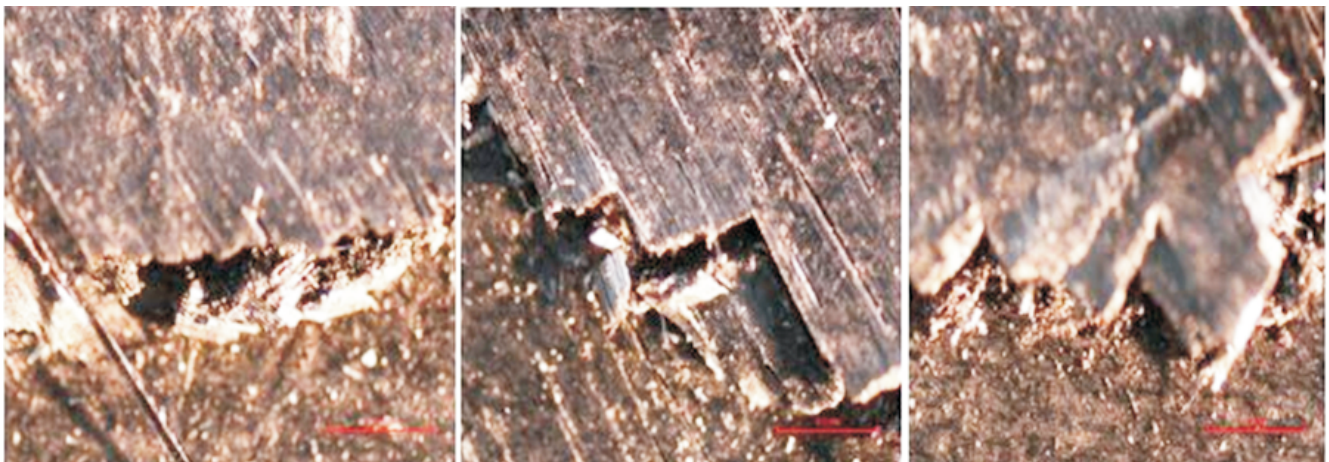
Figure 9. Optical microscope photos for Un1, Un2, and Un3: $[45/45/90/0]_{2s}$.

Optical microscope results show the shapes of the failure, which occurs in the samples. A high delaminated area occurs in $[45/45/90/0]_{2s}$ with the unbalance stacking sequence due to the orientation of the layer, and fibre orientation. **Figures 8** and **9** show photos taken in the transverse direction of the composite laminates for two types of stacking sequences.

In **Figure 8** the photos show a small delaminated area, and a small damage area, with almost same damage shape in the upper surface of the laminate. However, in **Figure 9**, we can see the biggest delaminated area, large damage indentation, various damage shapes, fibre failure, and debonding (splitting). Which could attributed to important role and effects of fibre orientation in composite laminates.

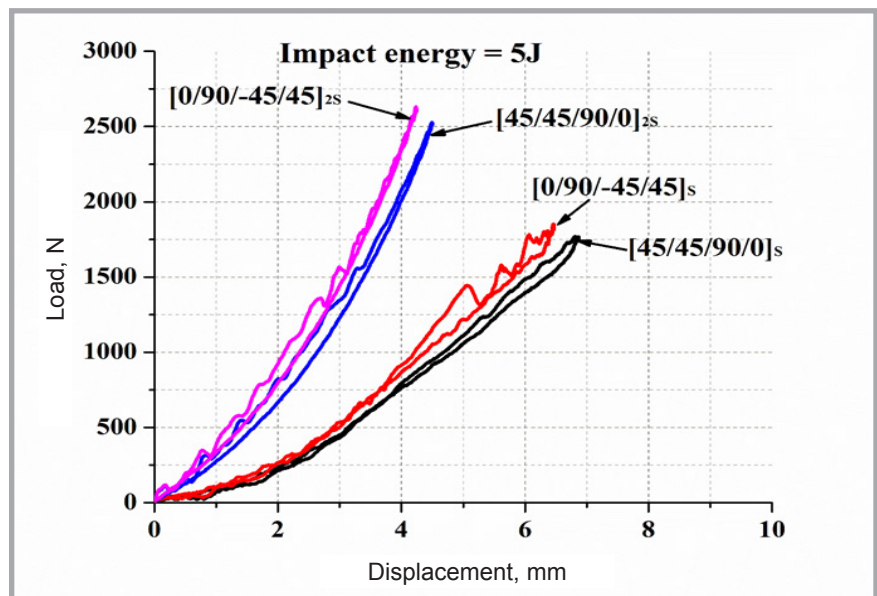
Figure 10. Load-displacement curves for low-velocity impact tests of composite laminates.

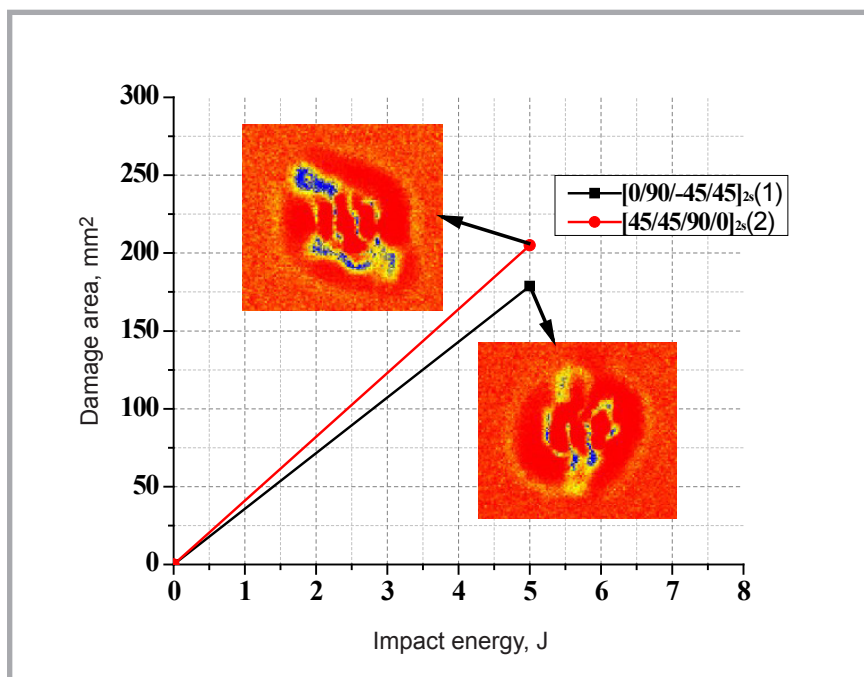
Figure 13. Measurement of damage area to top surfaces of laminates $[0/90/-45/45]_{2s}$ and $[45/45/90/0]_{2s}$ at 5 J from the C-scan image.

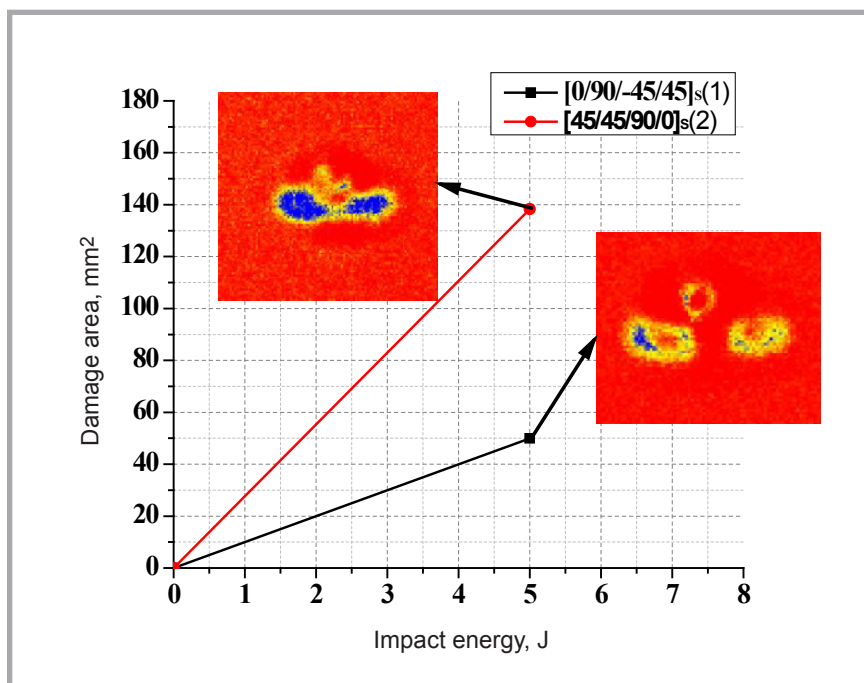
Figure 14. Measurement of damage area to top surfaces of laminates $[0/90/-45/45]_s$ and $[45/45/90/0]_s$ at 5 J from the C-scan image.
